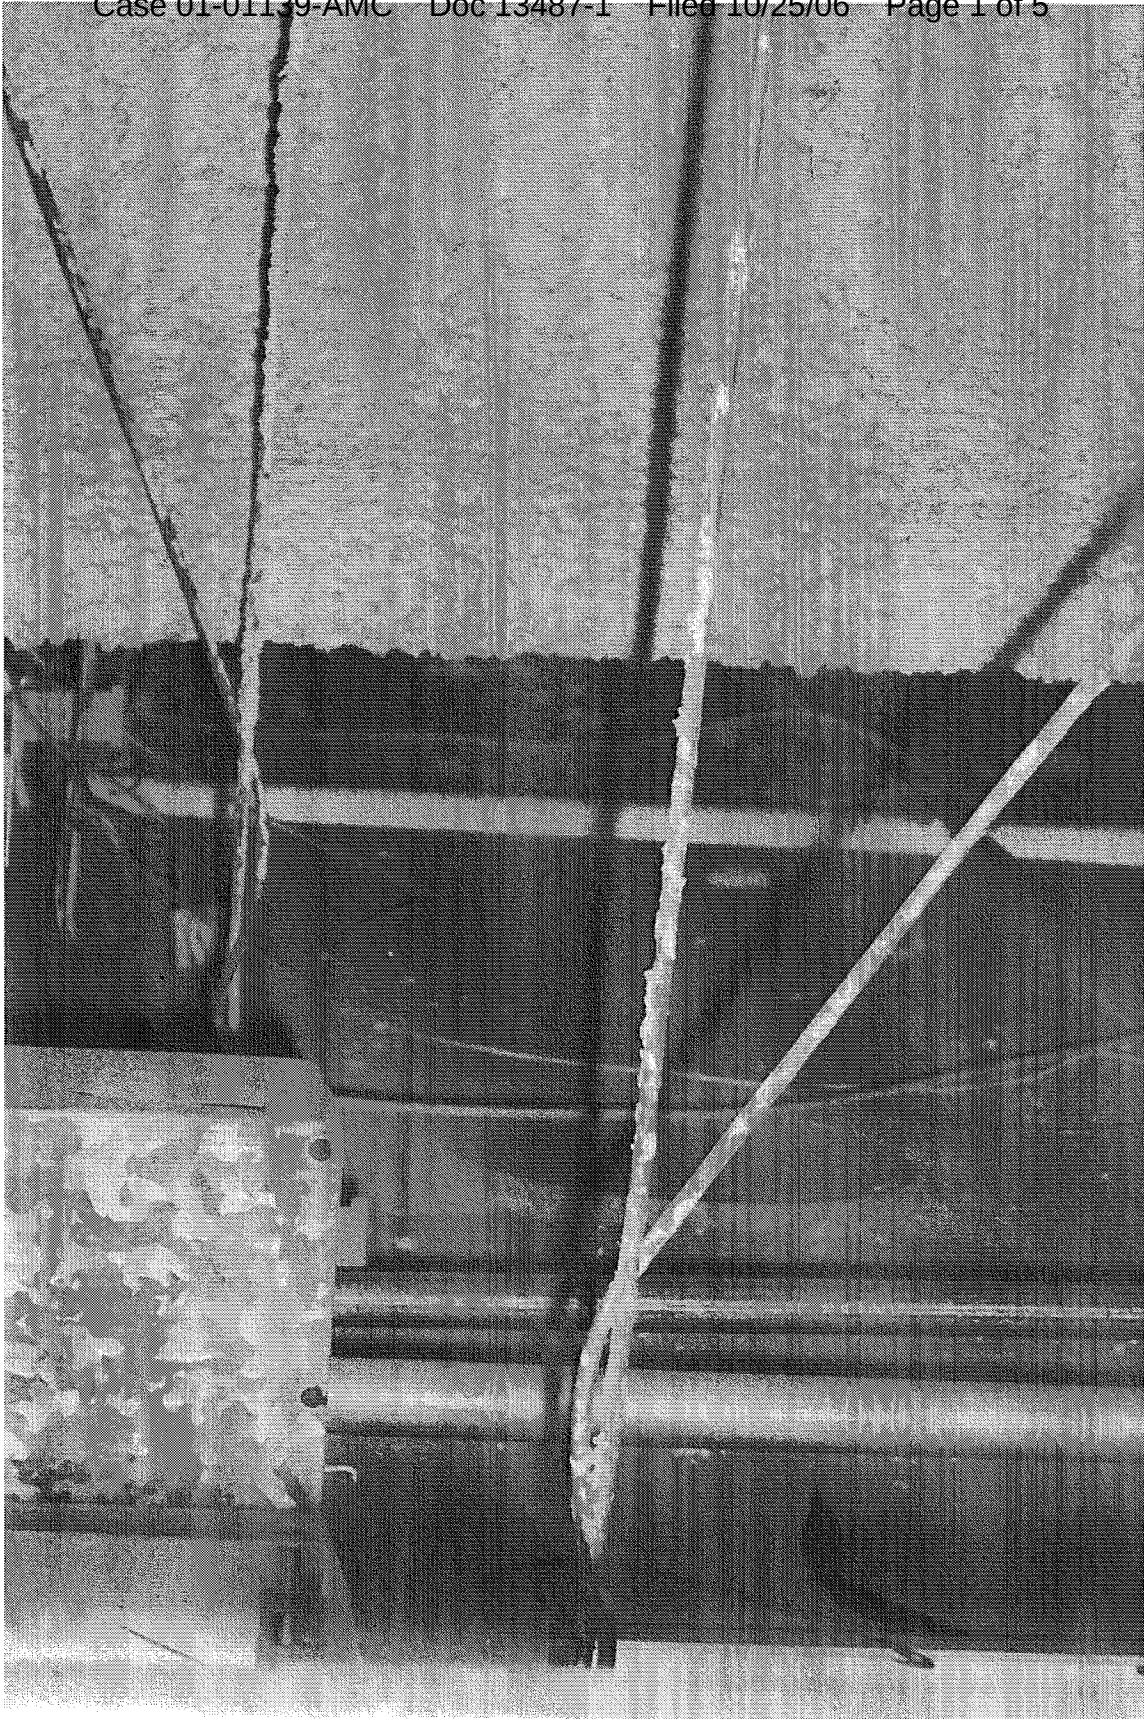
11. 19th floor, room E1951A - View of fireproofing above suspended ceiling

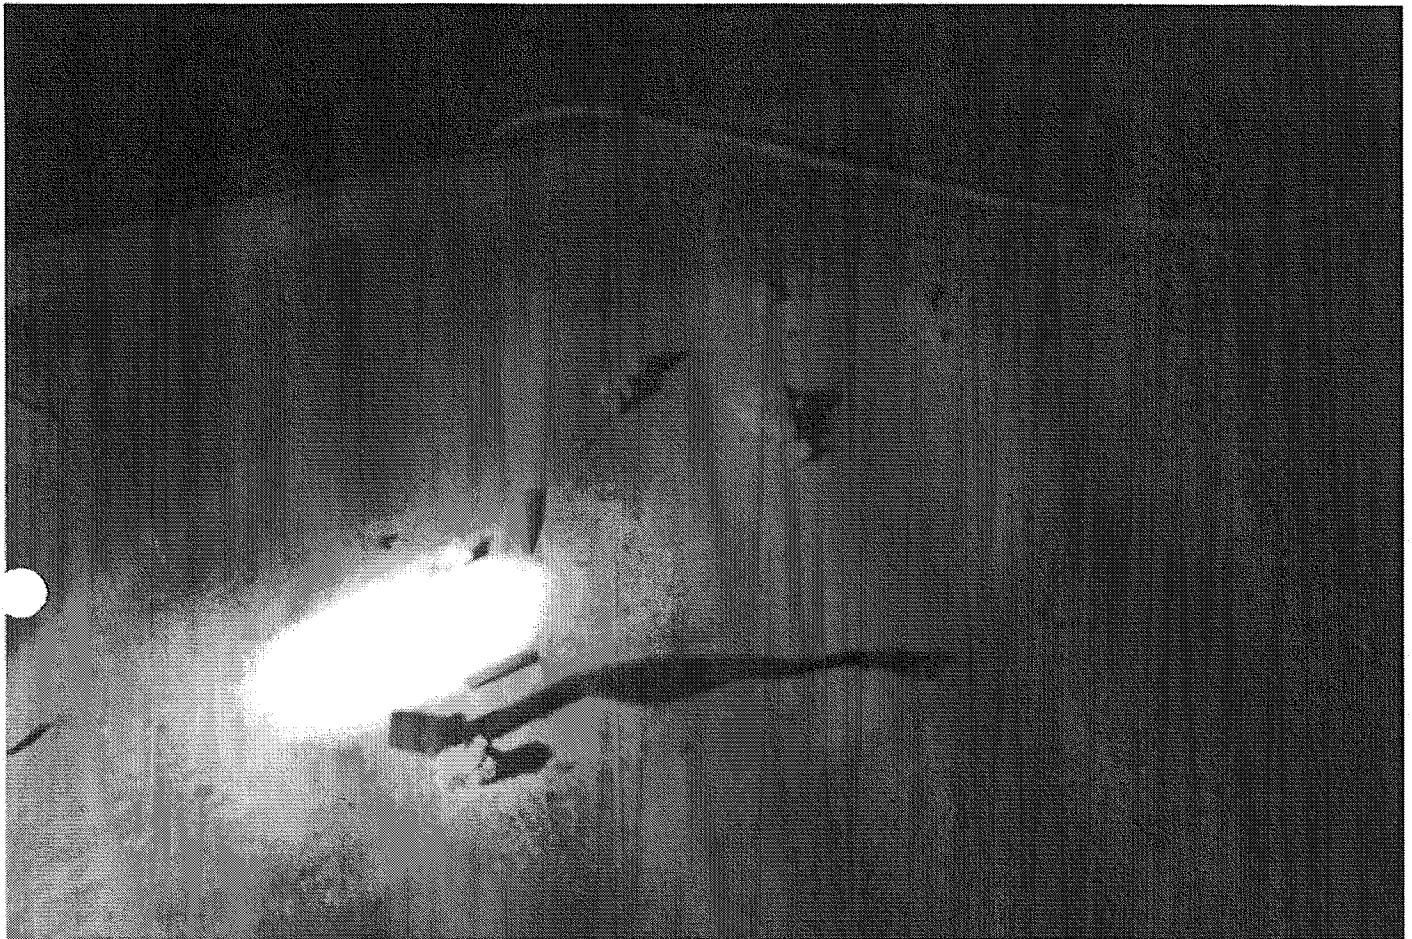
13. 19th floor, room S1951 - View of dislodged fire proofing debris on top of light fixture

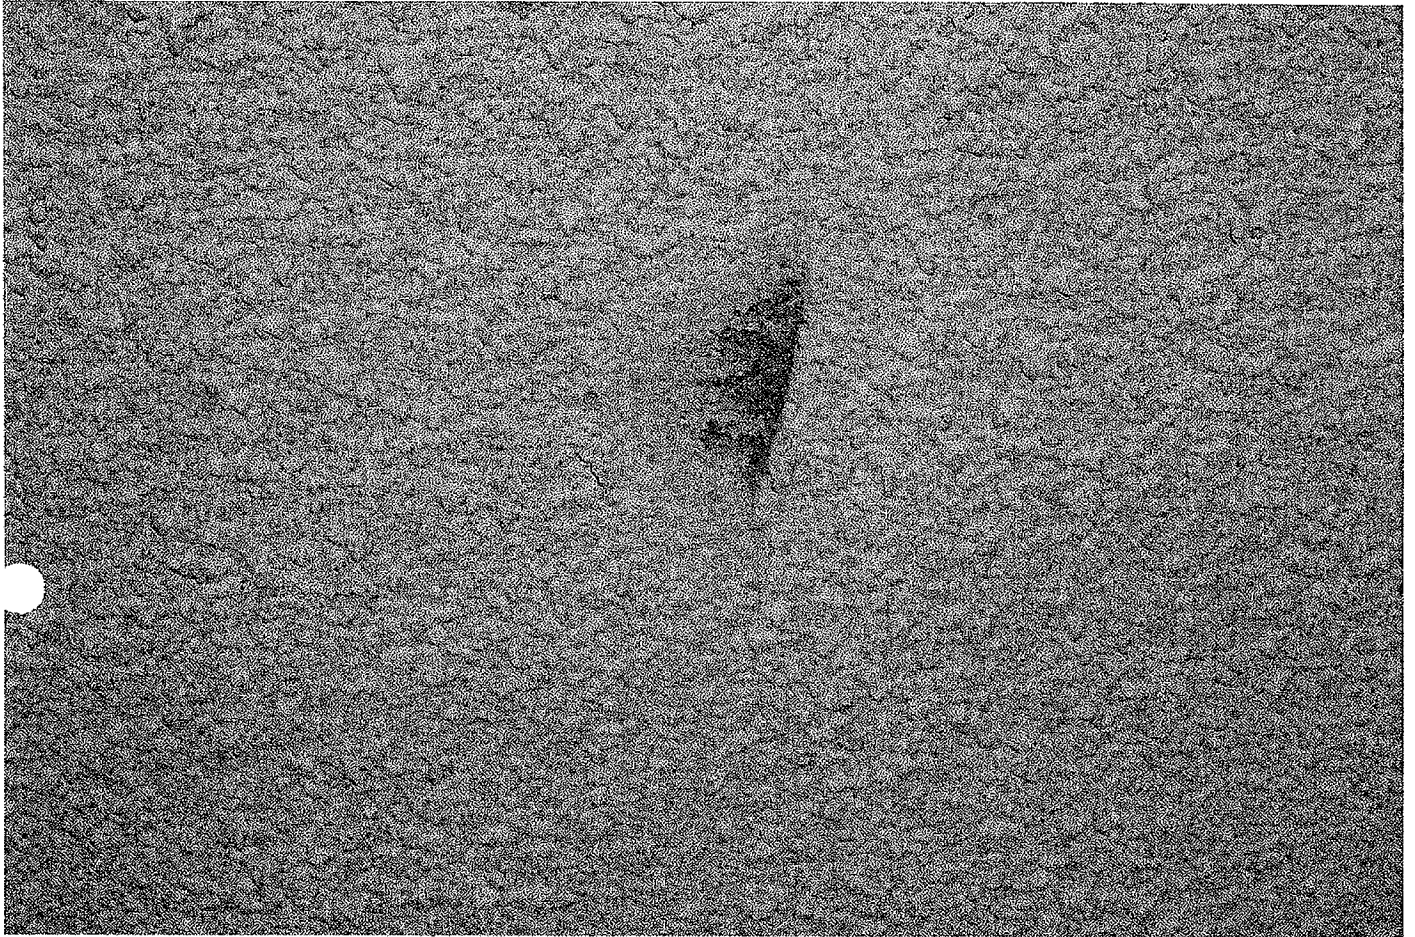
15. 19th floor, elevator lobby - center - View of impact damage to accoustical spray finish
